TREATMENT OF SANITARY WASTES AT INTERSTATE REST AREAS

J. E. Etzel

Interim Report

PHASE III, TREATMENT OF SANITARY WASTES AT INTERSTATE REST AREAS

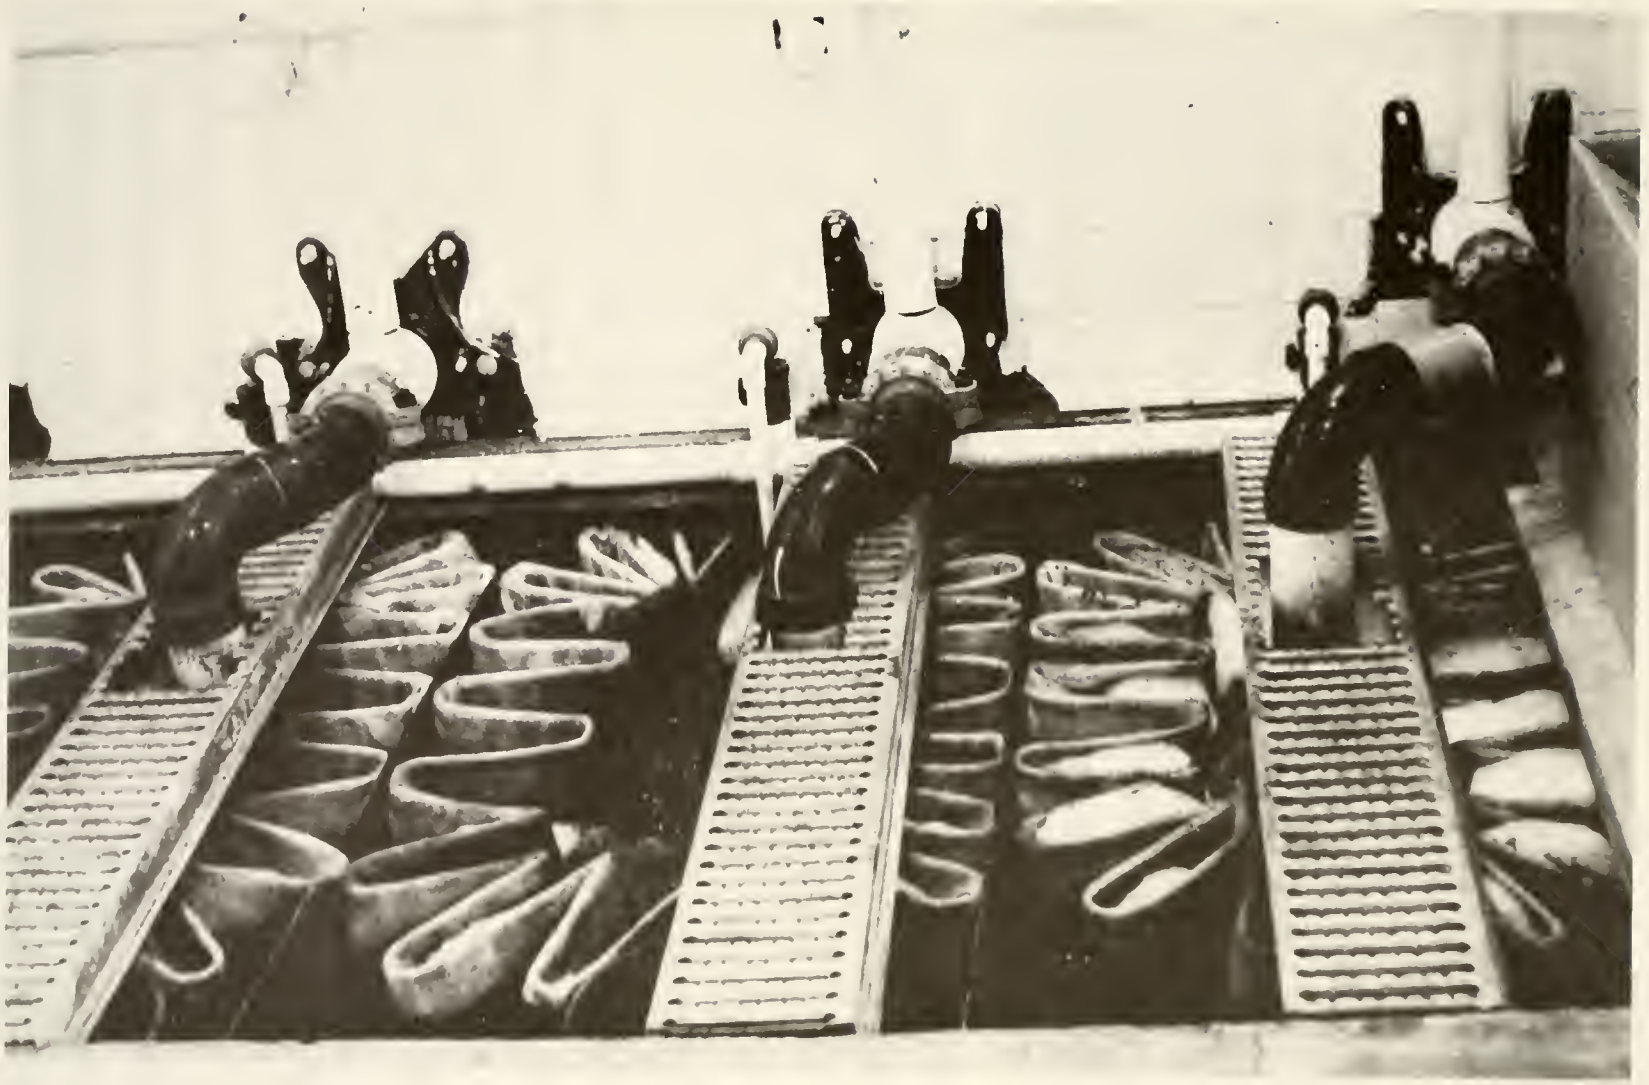
Figure 5 Photograph Showing Bags S-4, S-5, and S-6 on the Recycle System
(Photo taken by Lafayette Journal and Courier)

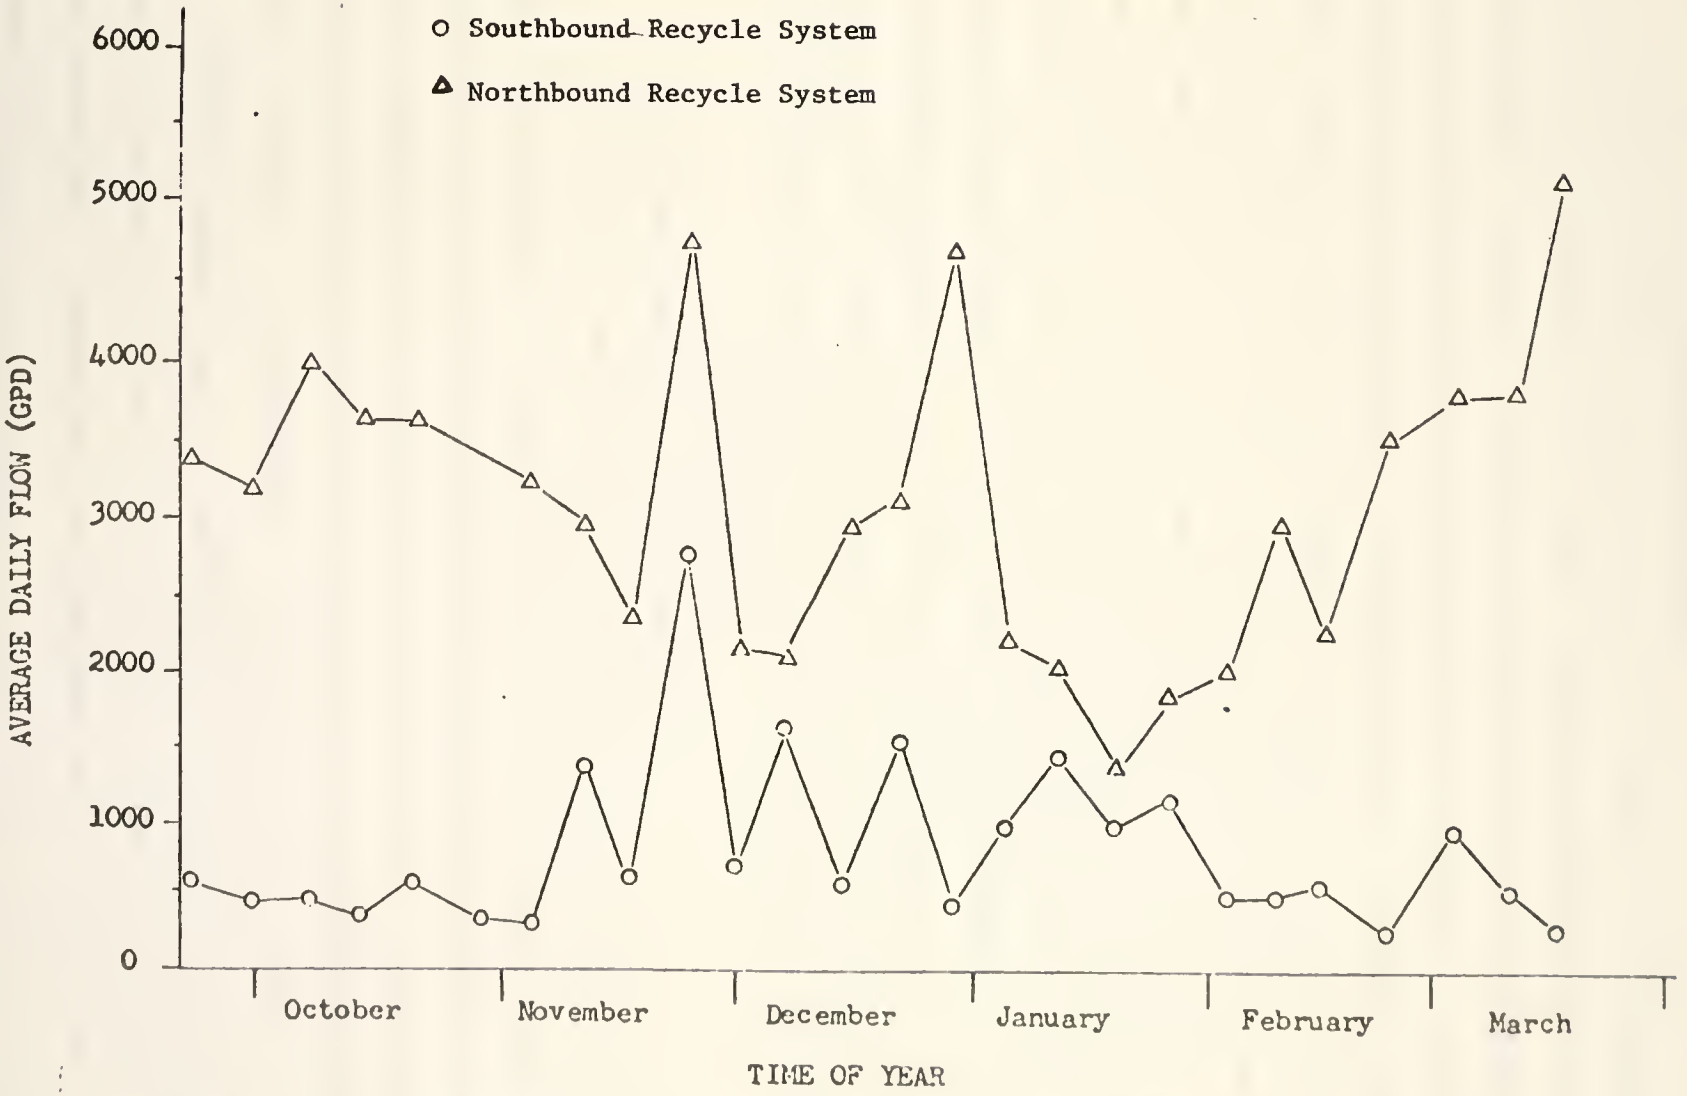
FIGURE 8. Weekly water Usage on Once Through and Recycle Systems.

valves were not a serious problem. During the months from November through January, stuck flushometer valves were a serious problem and this is why water consumption fluctuated so much on the recycled system, as shown in Figure 8.
